# Holloways & Clifton Beach Coastal Resilience Works

Sam King | International Coastal Management

# The Holloways and Clifton Beach Erosion Management Project

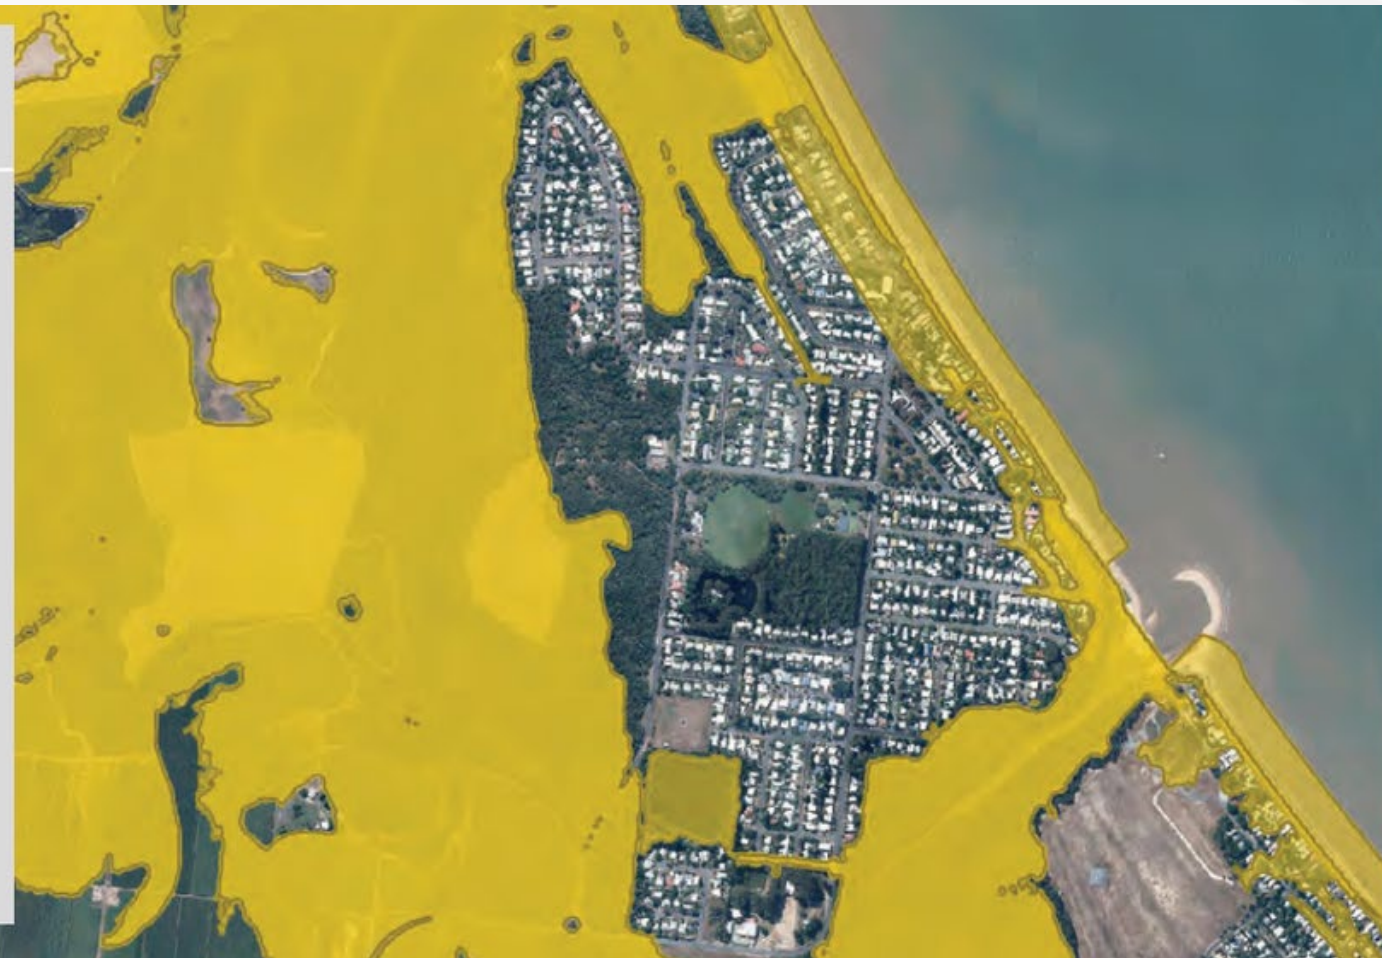
Located about 10 km north of Cairns, experiencing significant coastal erosion over the years

## COMMUNITY ASSETS AT RISK BY 2100

- Beaches
- Community infrastructure (e.g. Machans Beach Progress Association Hall and Holloways Beach Environmental Centre)
- Foreshore parks and environmental areas
- Tourist accommodation
- Important infrastructure (e.g. Australian Federal Police Asset and Radar Station)
- Various roads (e.g. Casuarina Street, O'Shea Esplanade and Marshall Street)
- Servicing (e.g. water and sewer pipes)

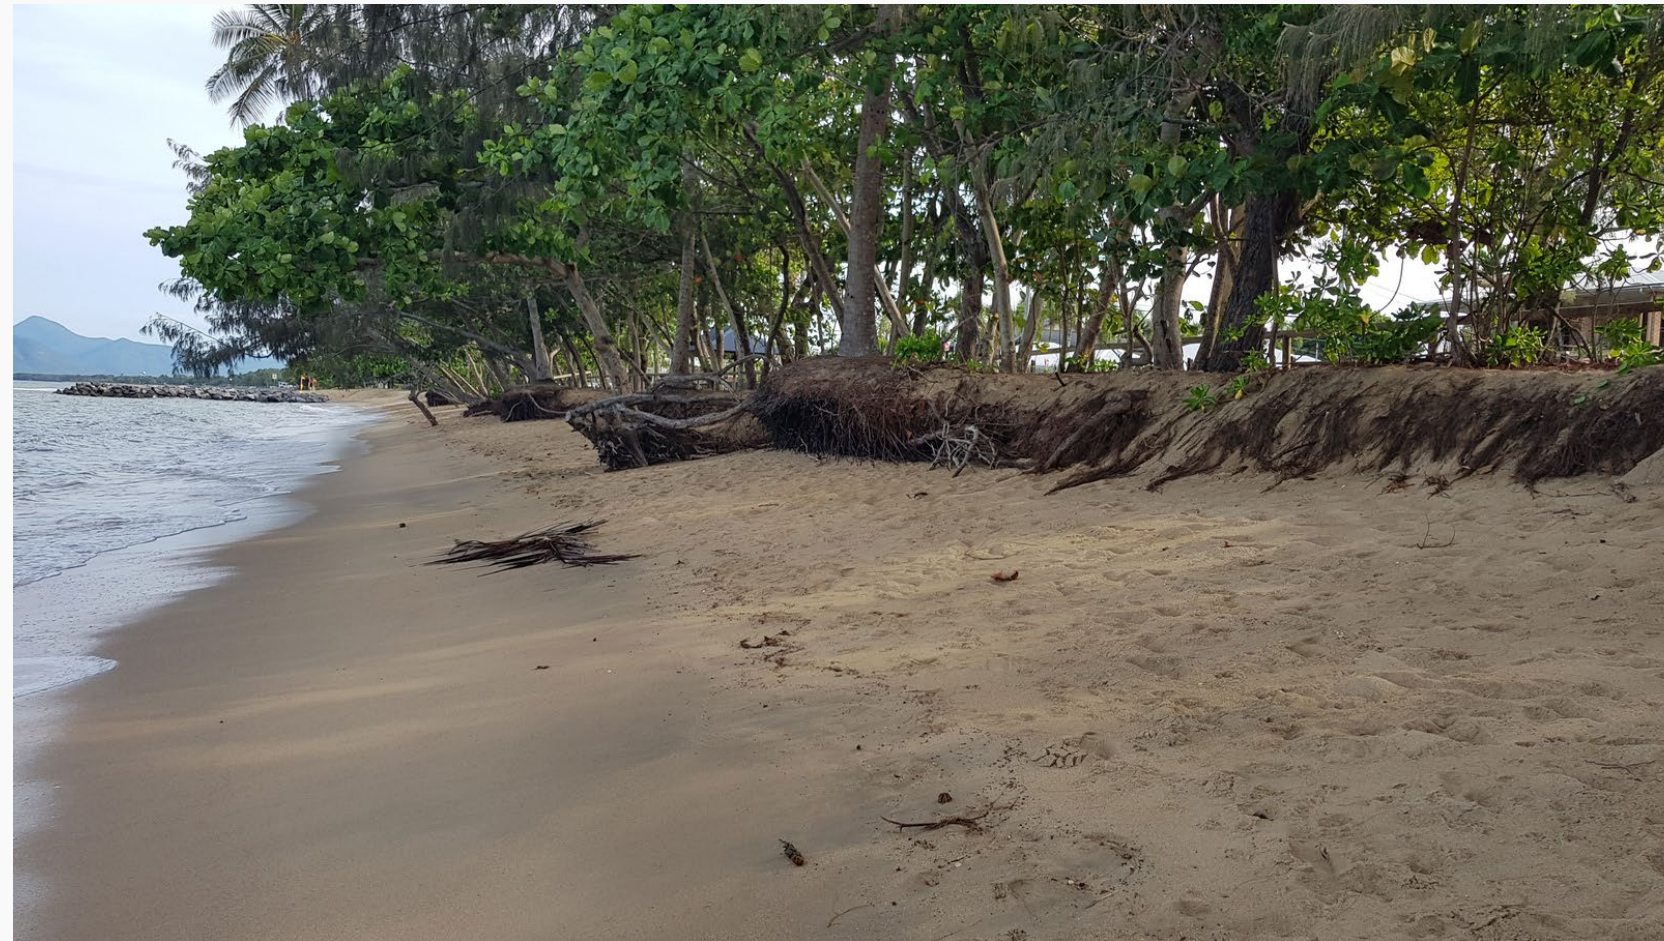
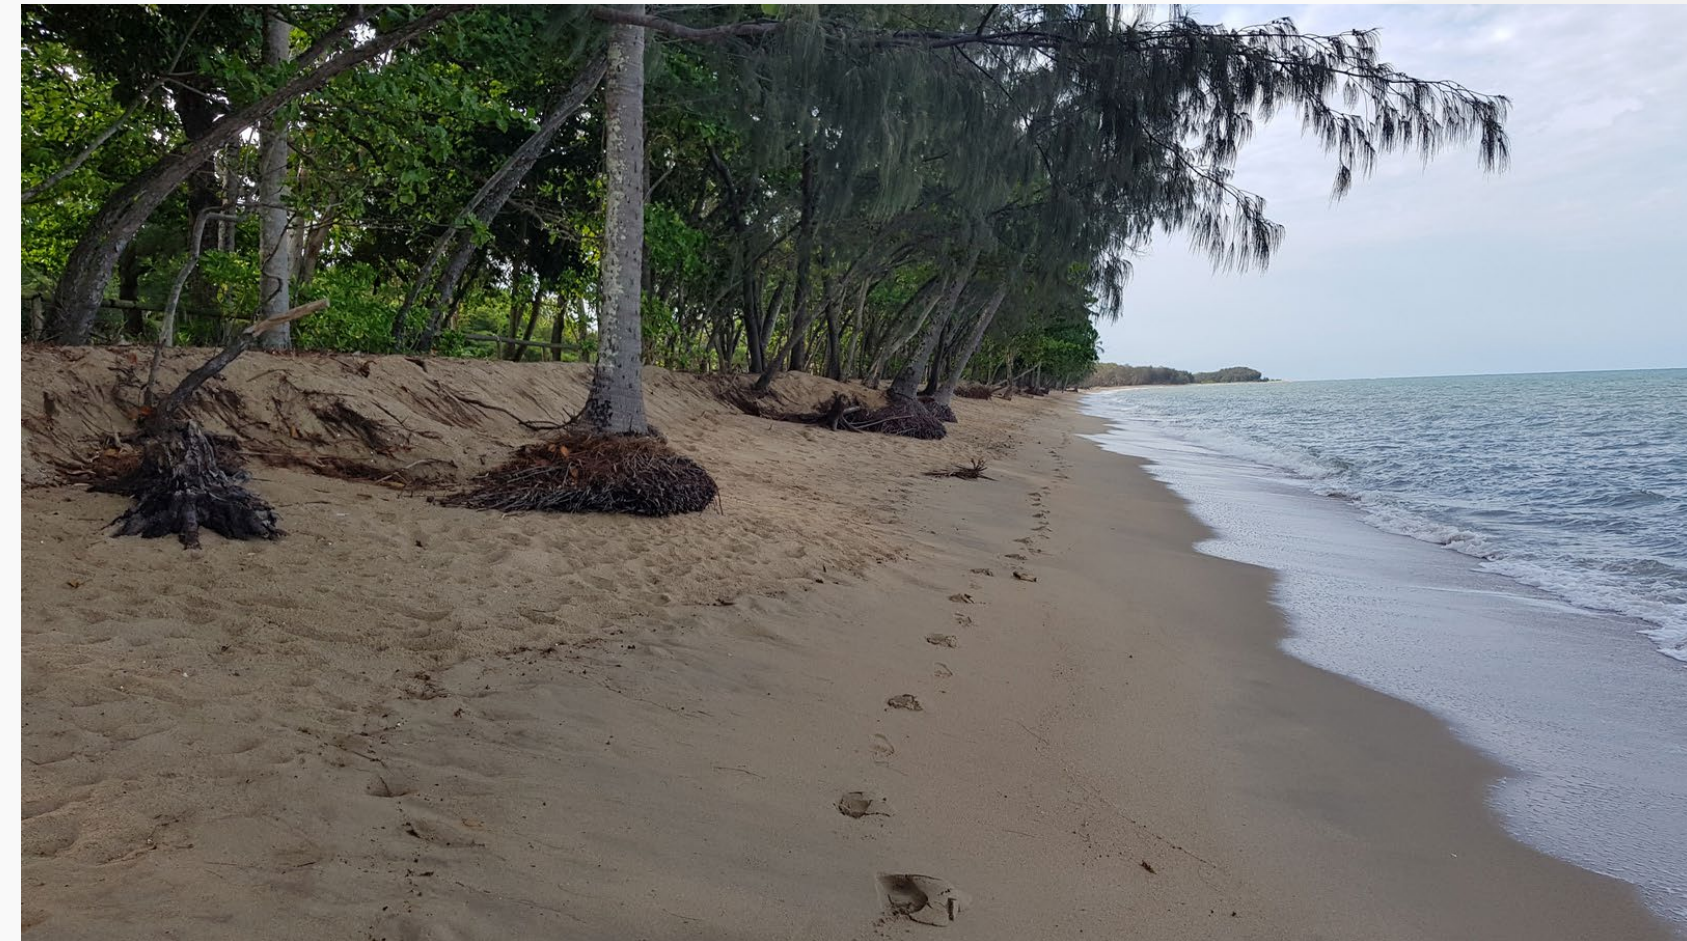
## Previous coastal works

- Rock revetment seawall
- Sand nourishment (on the upper beach)
- Geotextile sandbag groyne
- Rock groyne

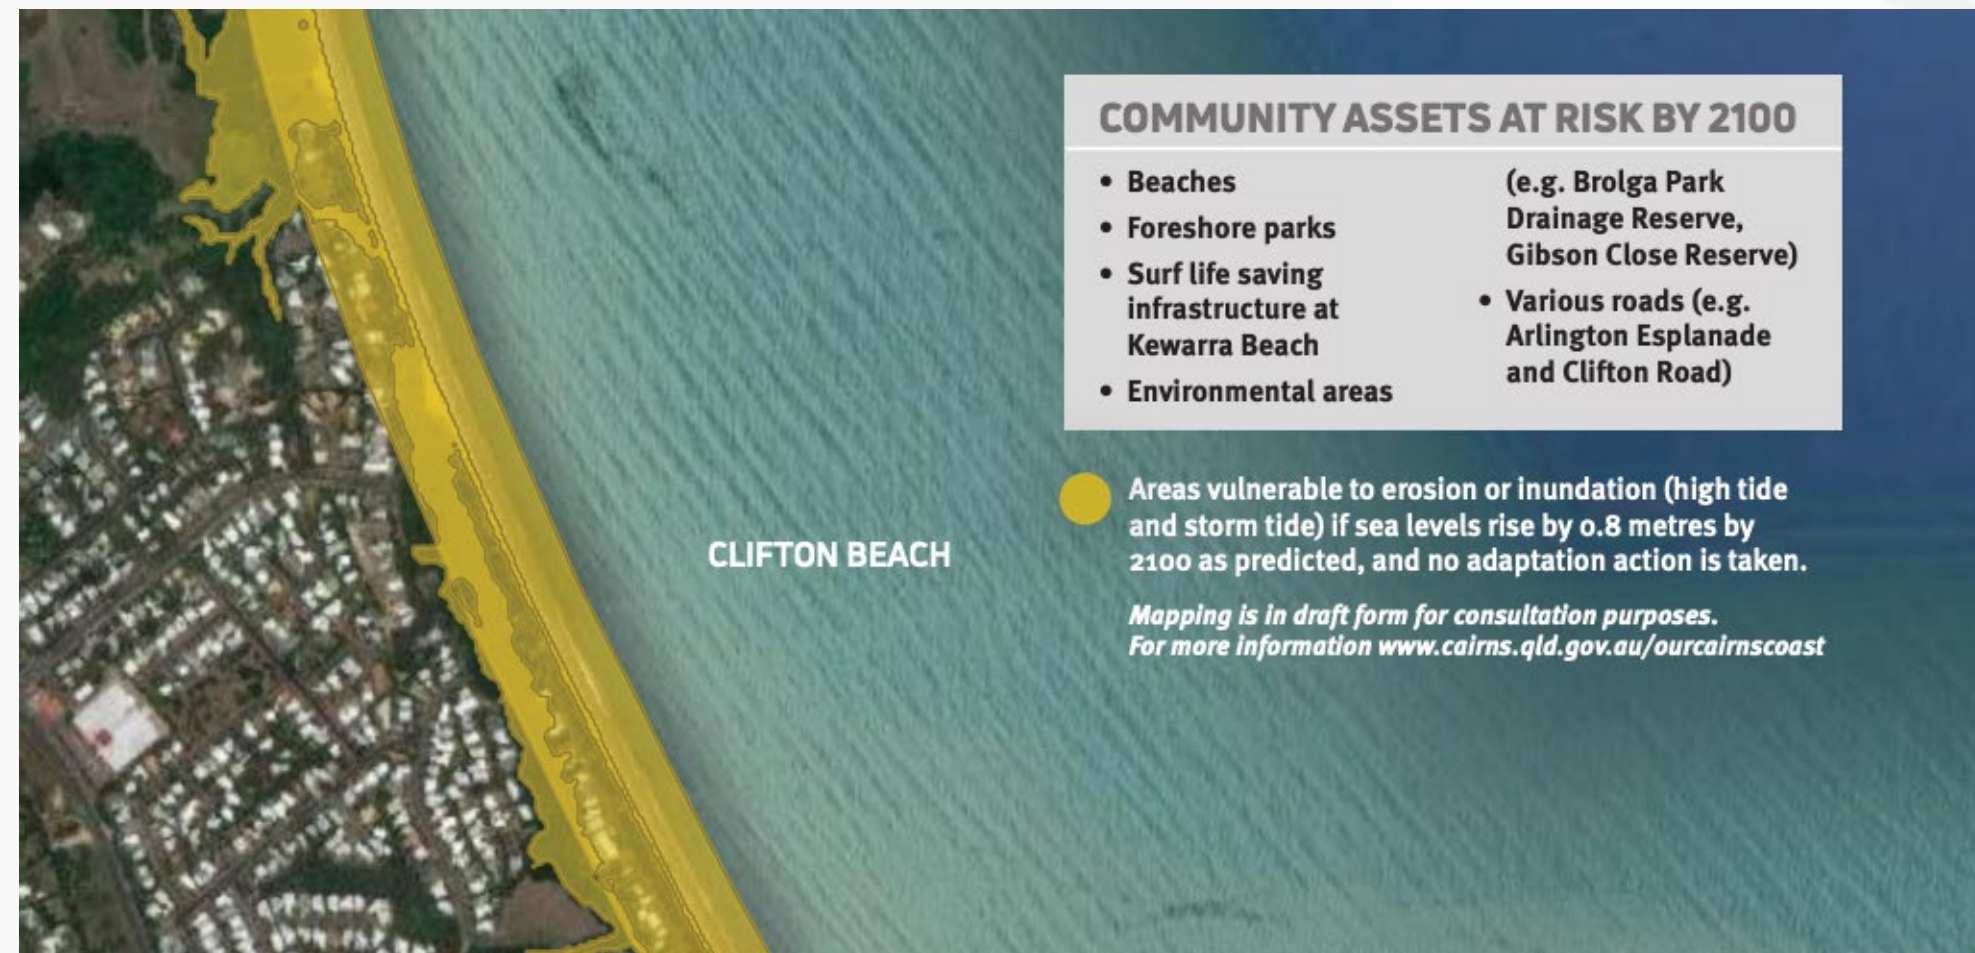
Located about 23 km north of Cairns, experienced persistent shoreline recession resulting in a loss of dunes

## Previous coastal works

- 550m long rock seawall
- Beach nourishment
- Development along Kewarra Beach is setback from the shoreline

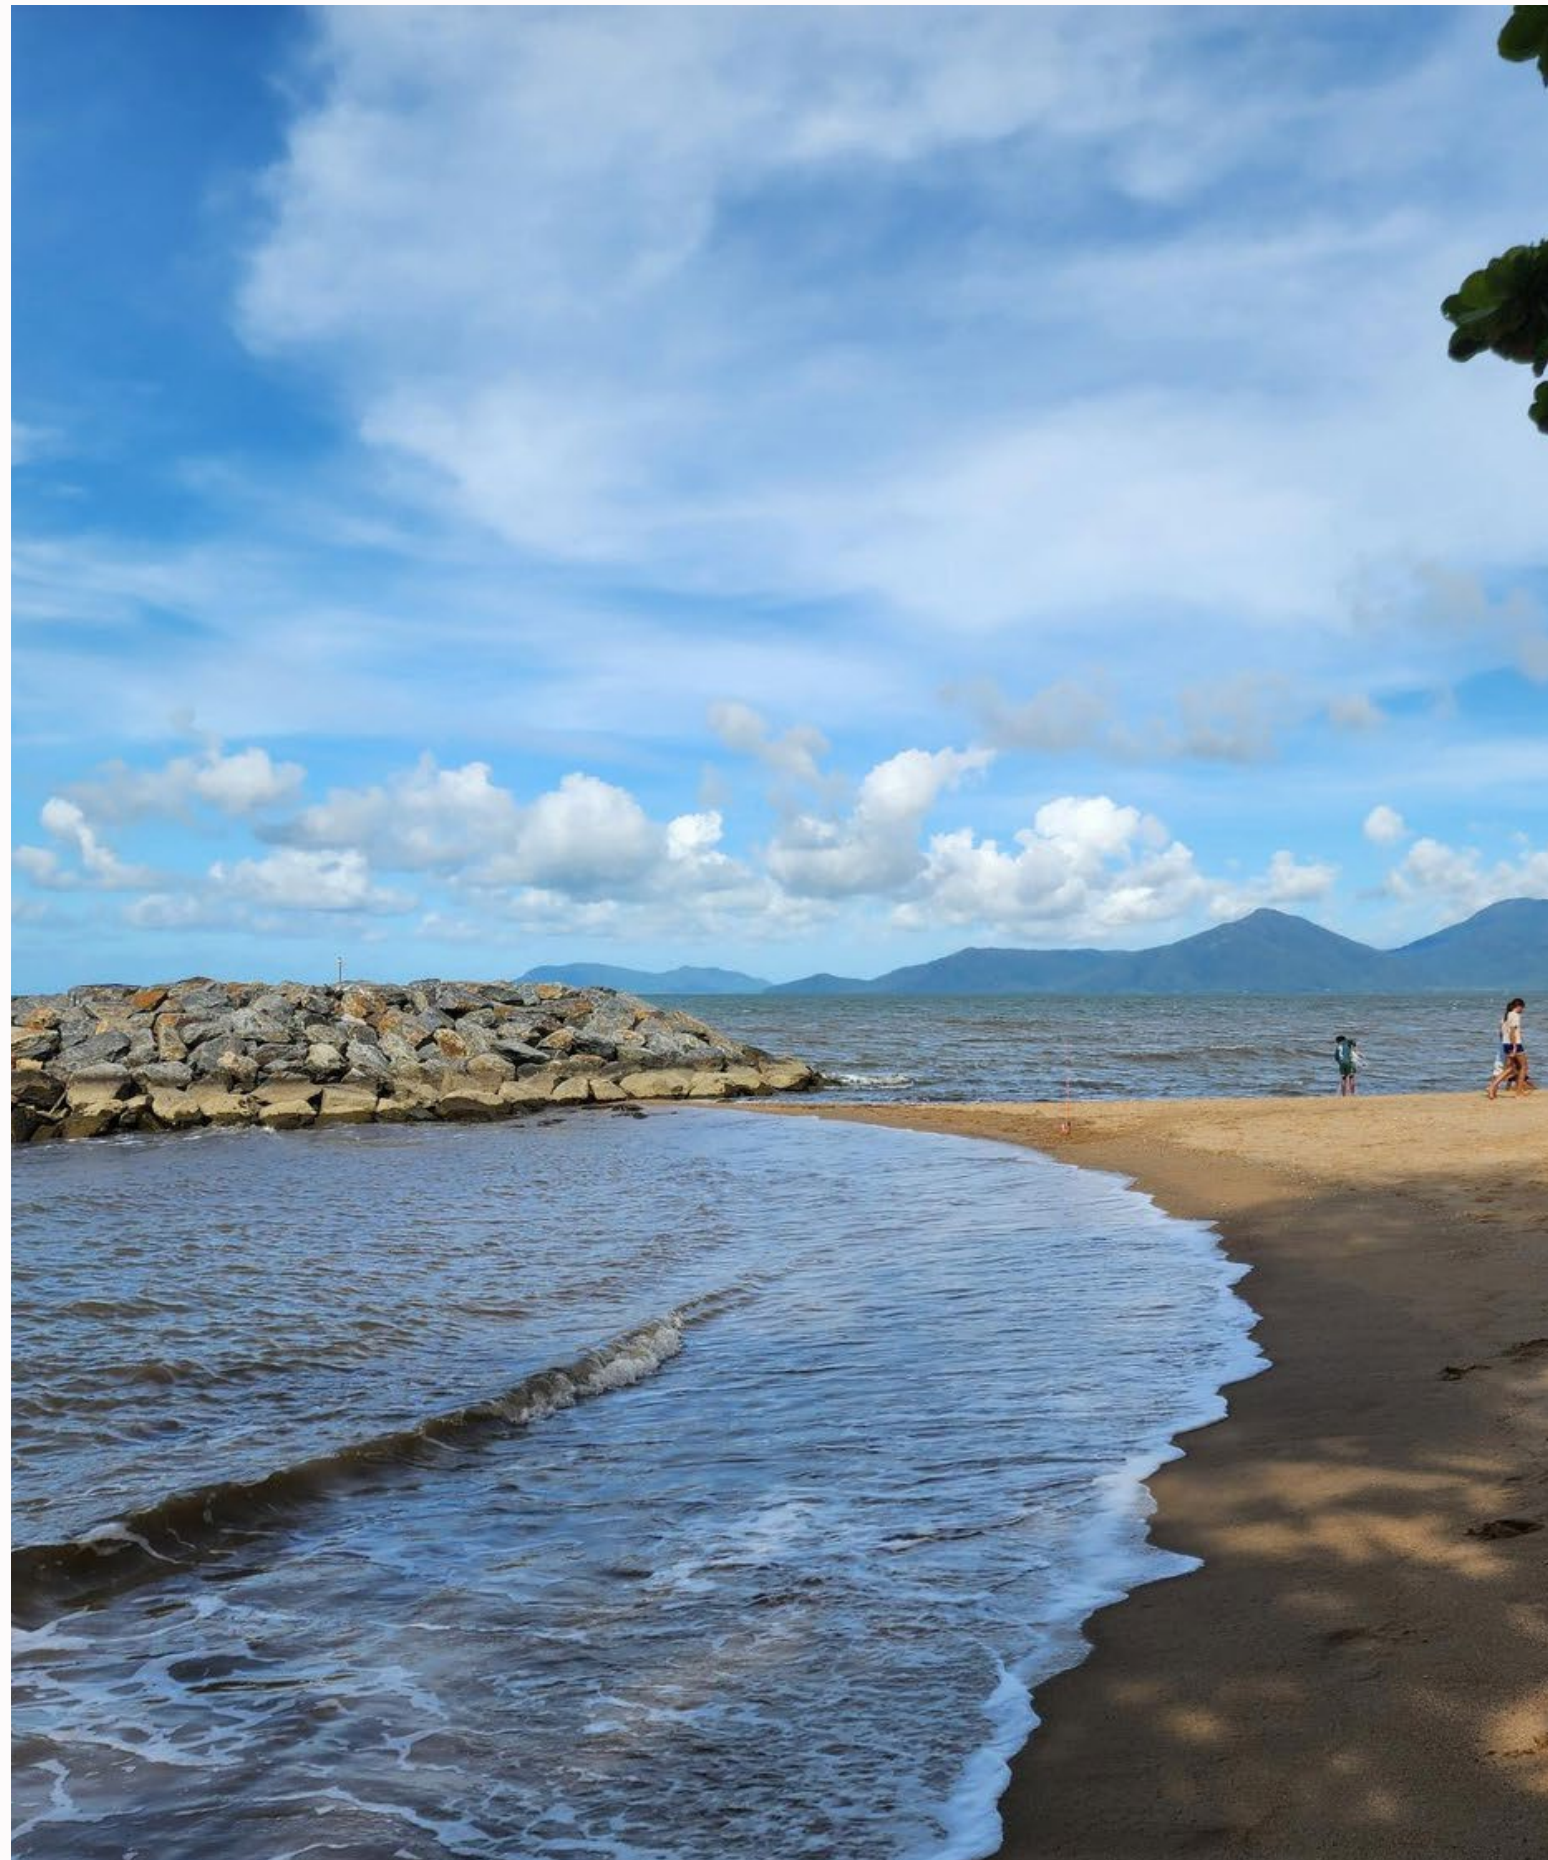
Designed influence the incident wave field to promote a 'soft' sand groyne in the lee and encourage updrift beach stability while allowing for increased bypassing at higher tides and storms.

**Located on the wide -low tide shelf present at the site and constructed from the beach.**

Particularly suitable for Far North Queensland beach profiles.

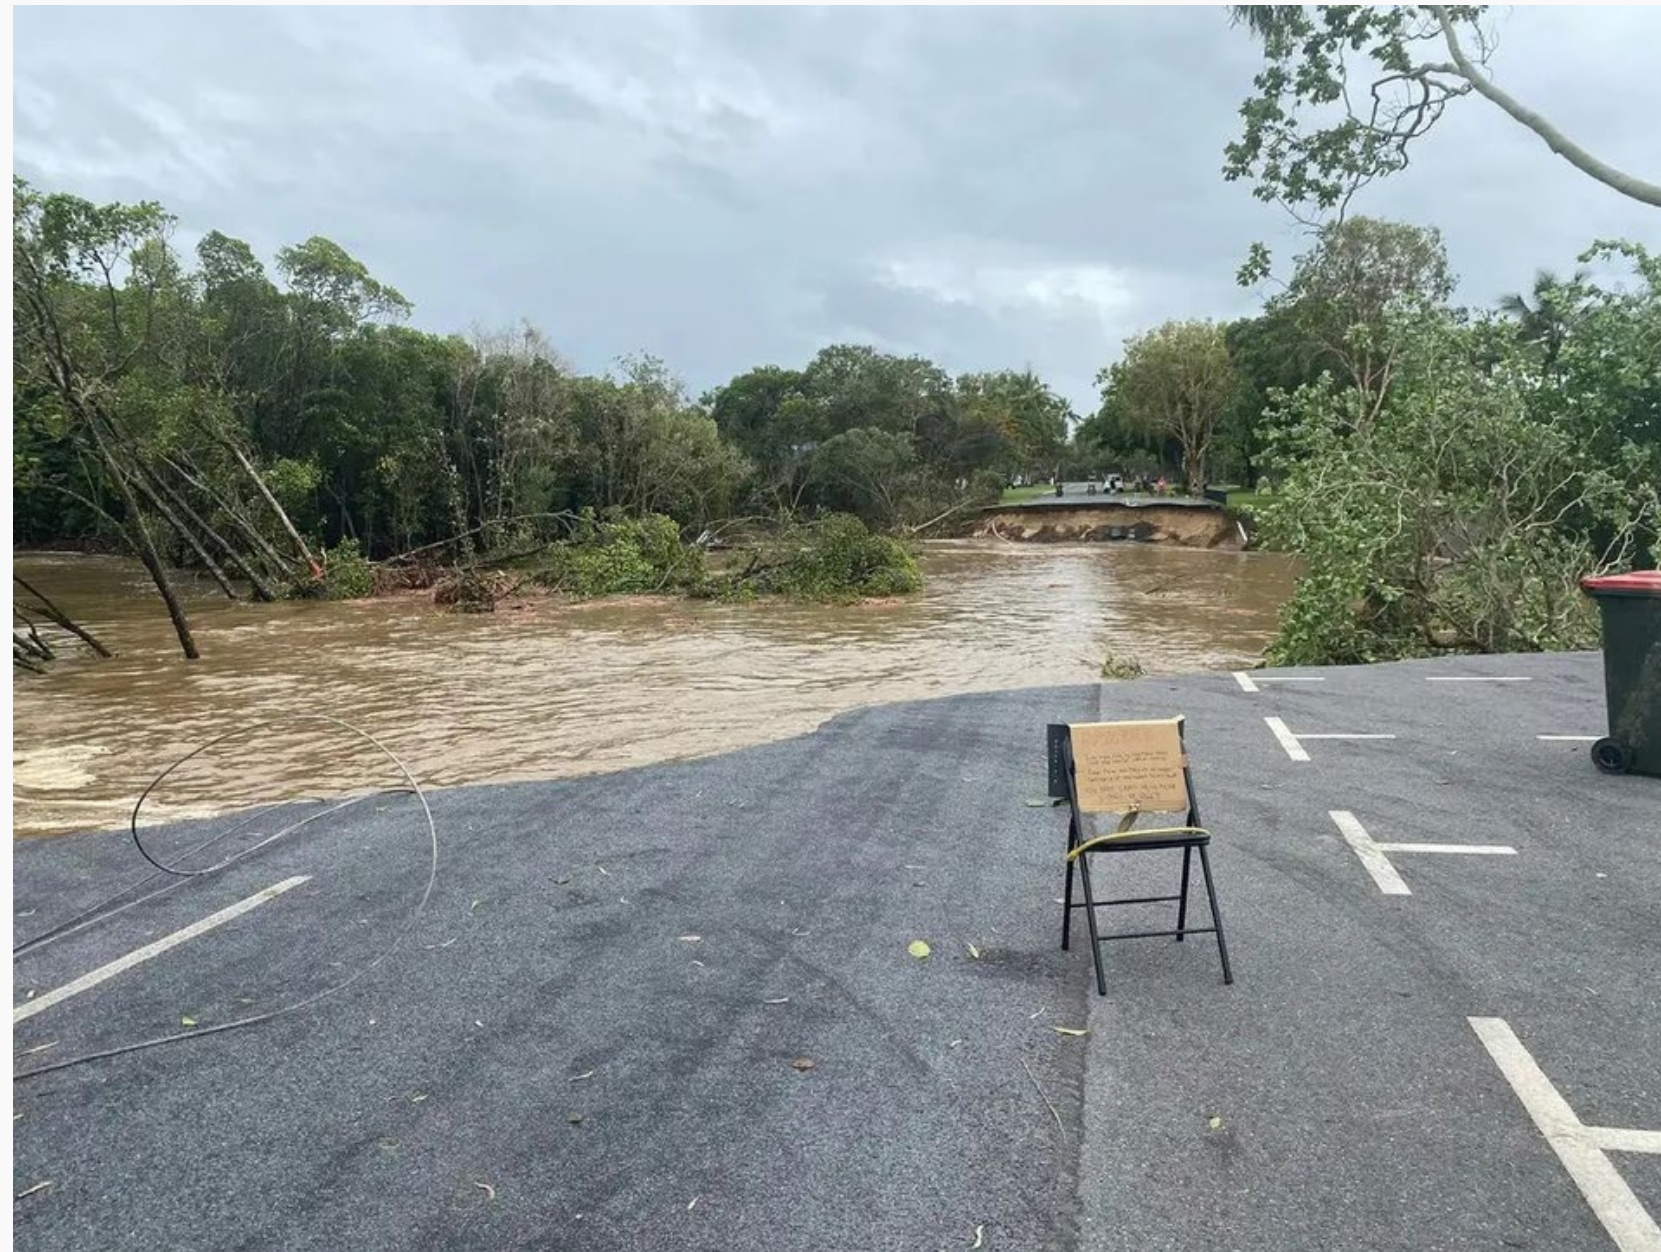
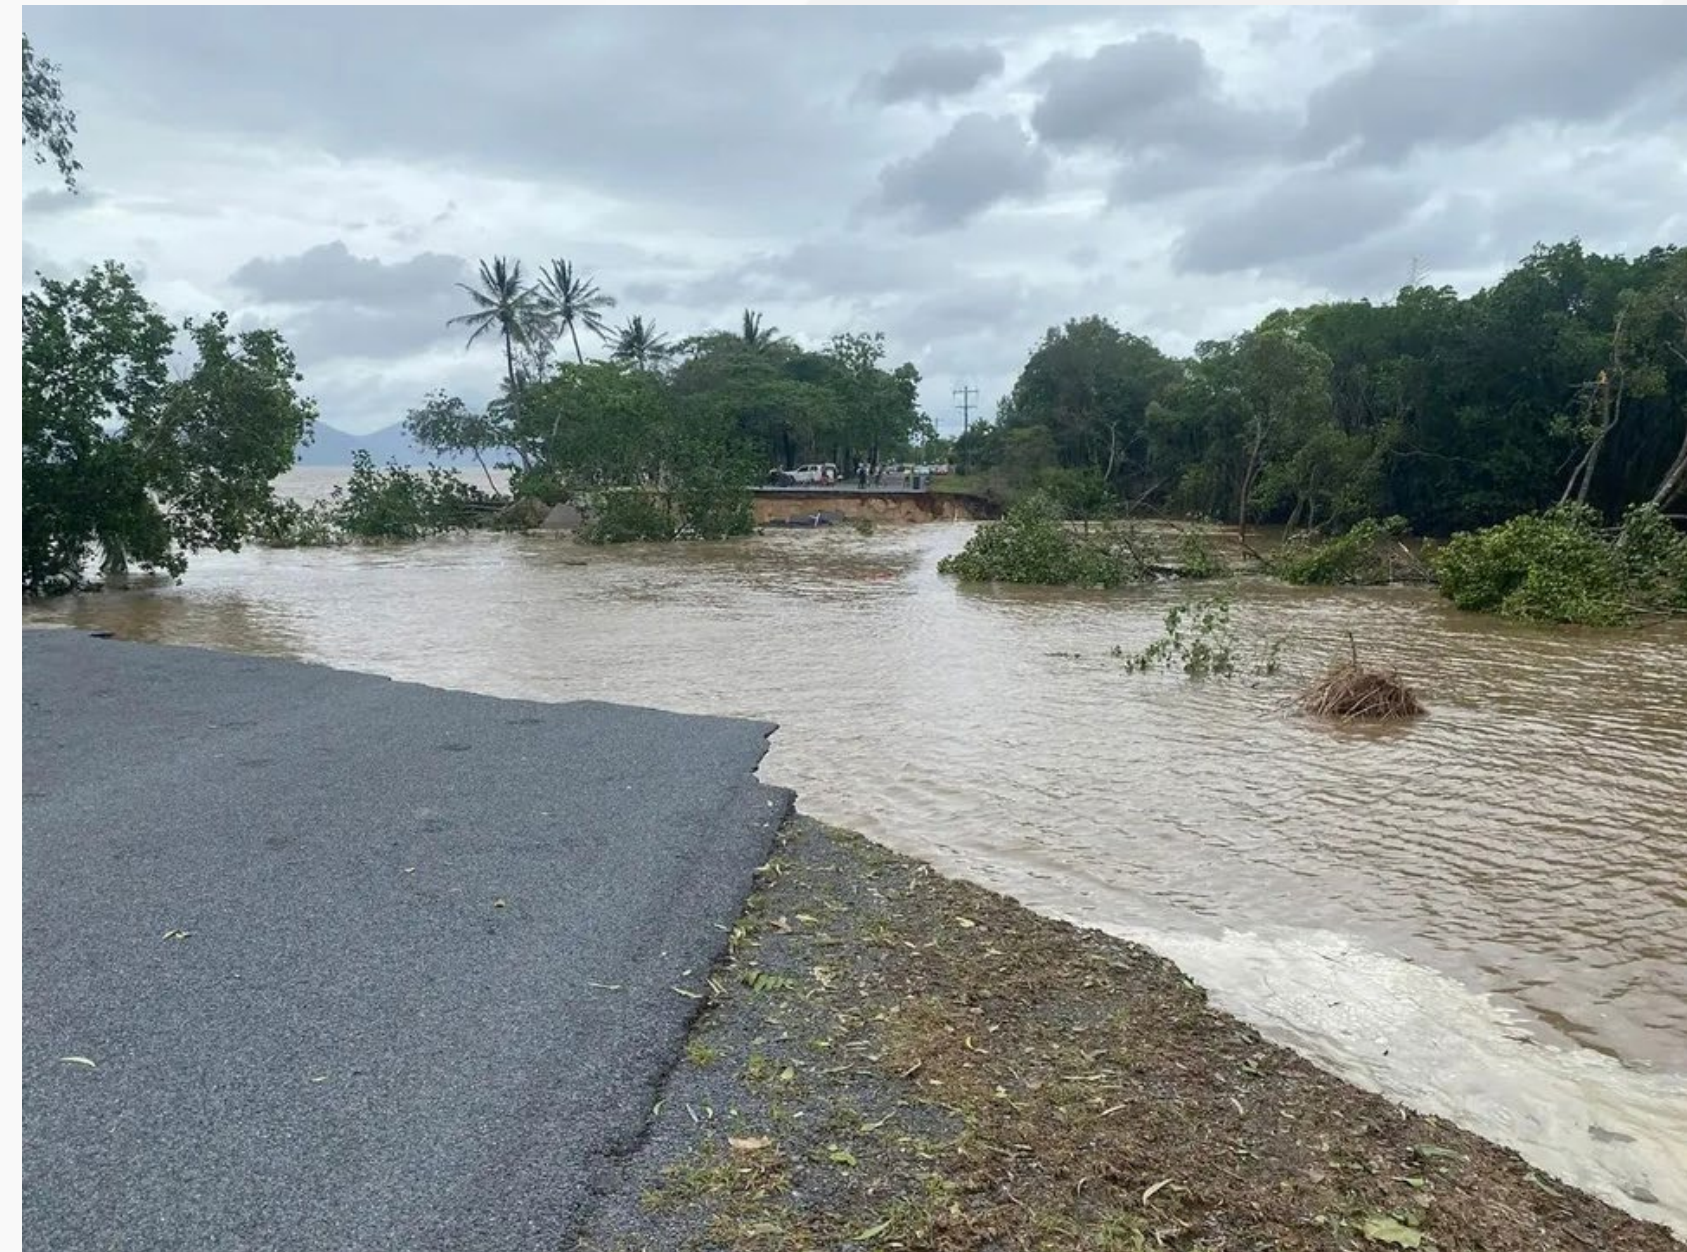
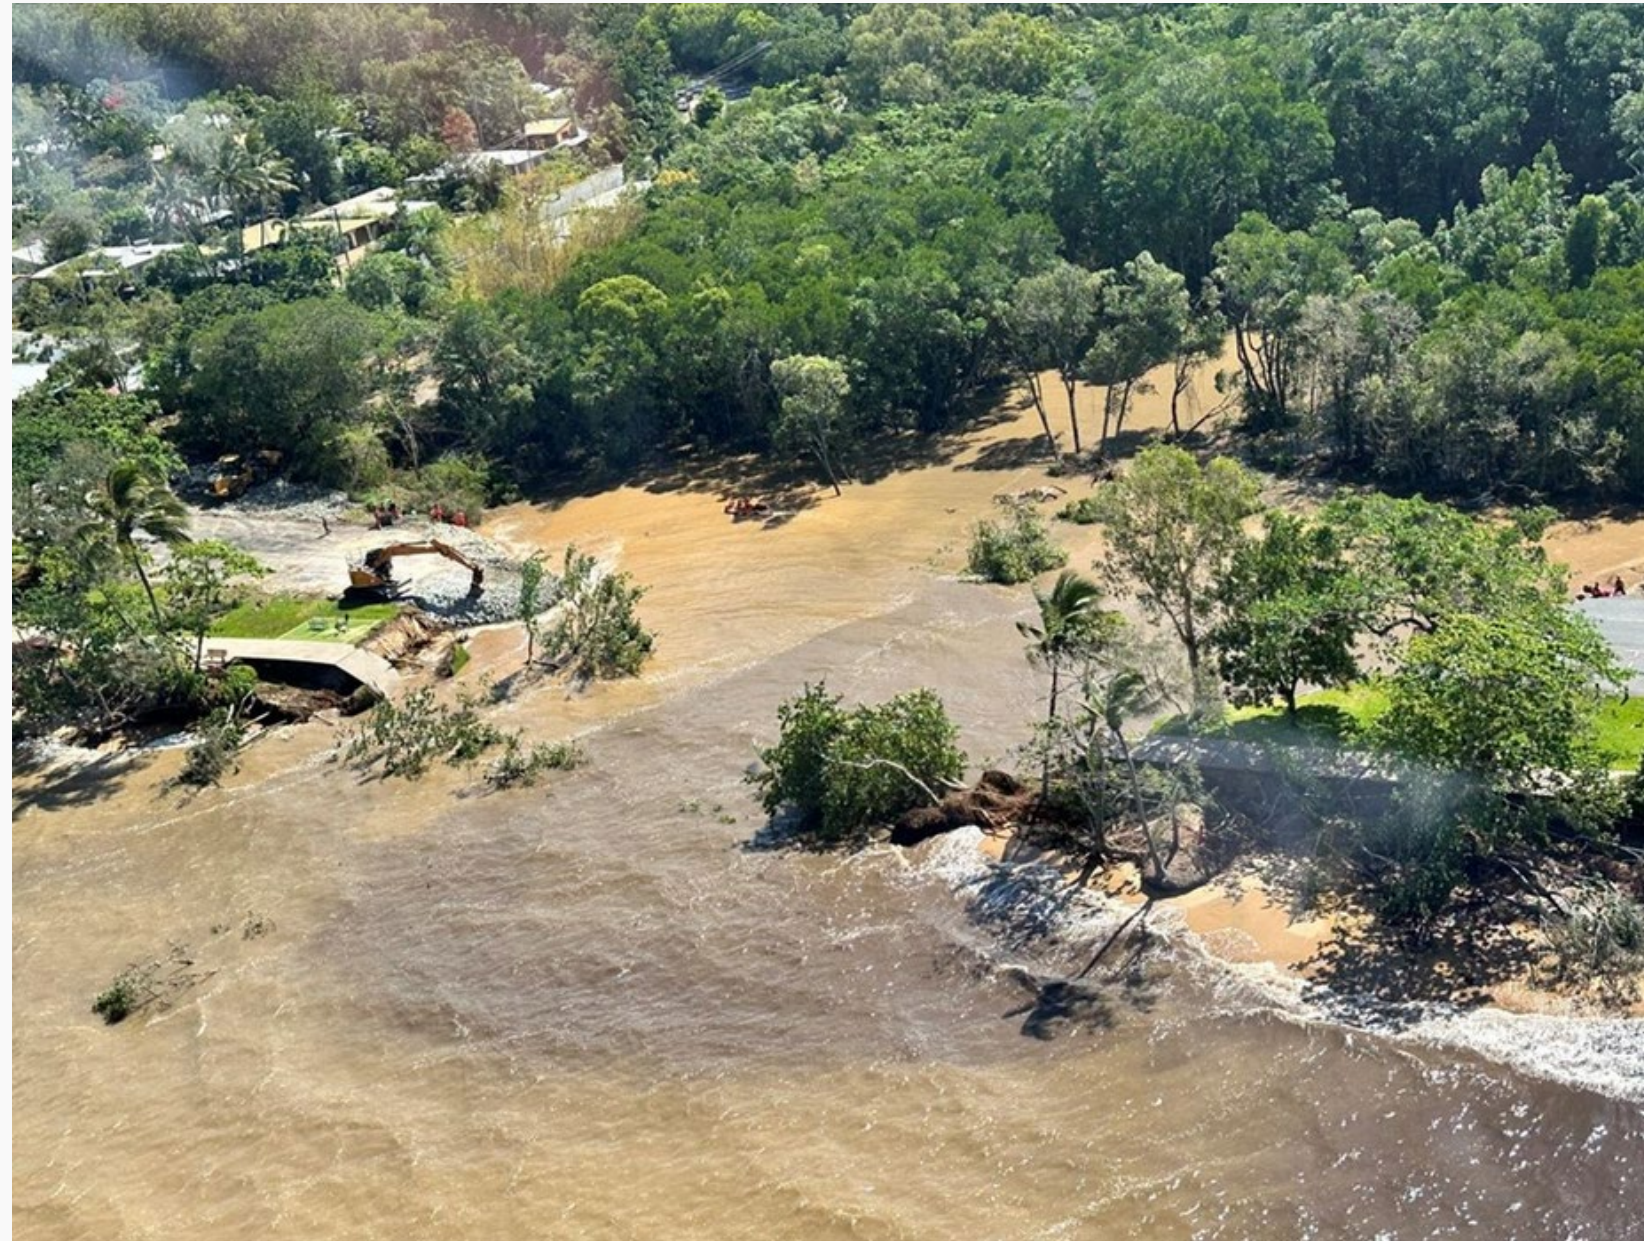
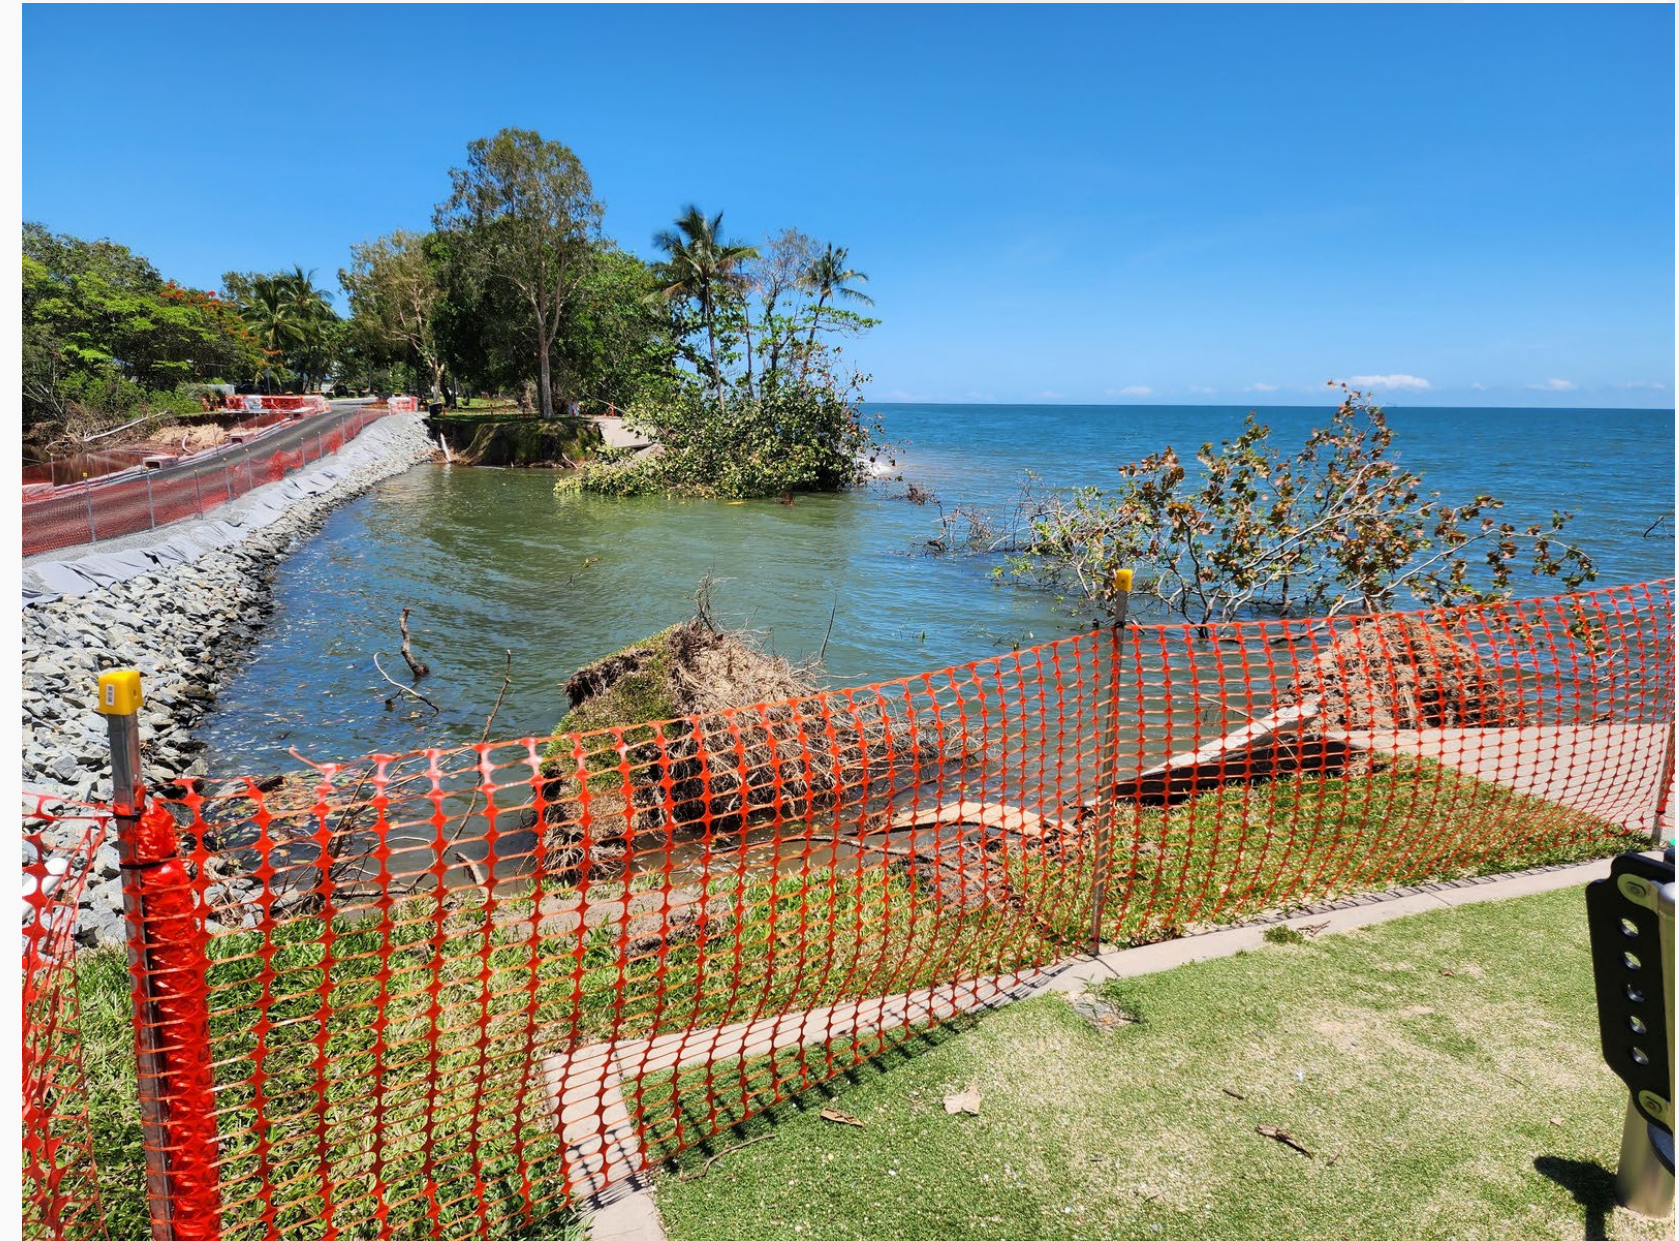
Brought heavy rain and record flooding to Far North Queensland (Dec 2023)

- Flooding of the Barron River breached Casuarina Street at Holloways Beach, flushing 20,000m<sup>3</sup> - 30,000m<sup>3</sup> of material offshore.
- Loss of access road to residential properties, parkland, public assets and impacts to the littoral system.
- Post-TC formation of large salient as the breach recovered

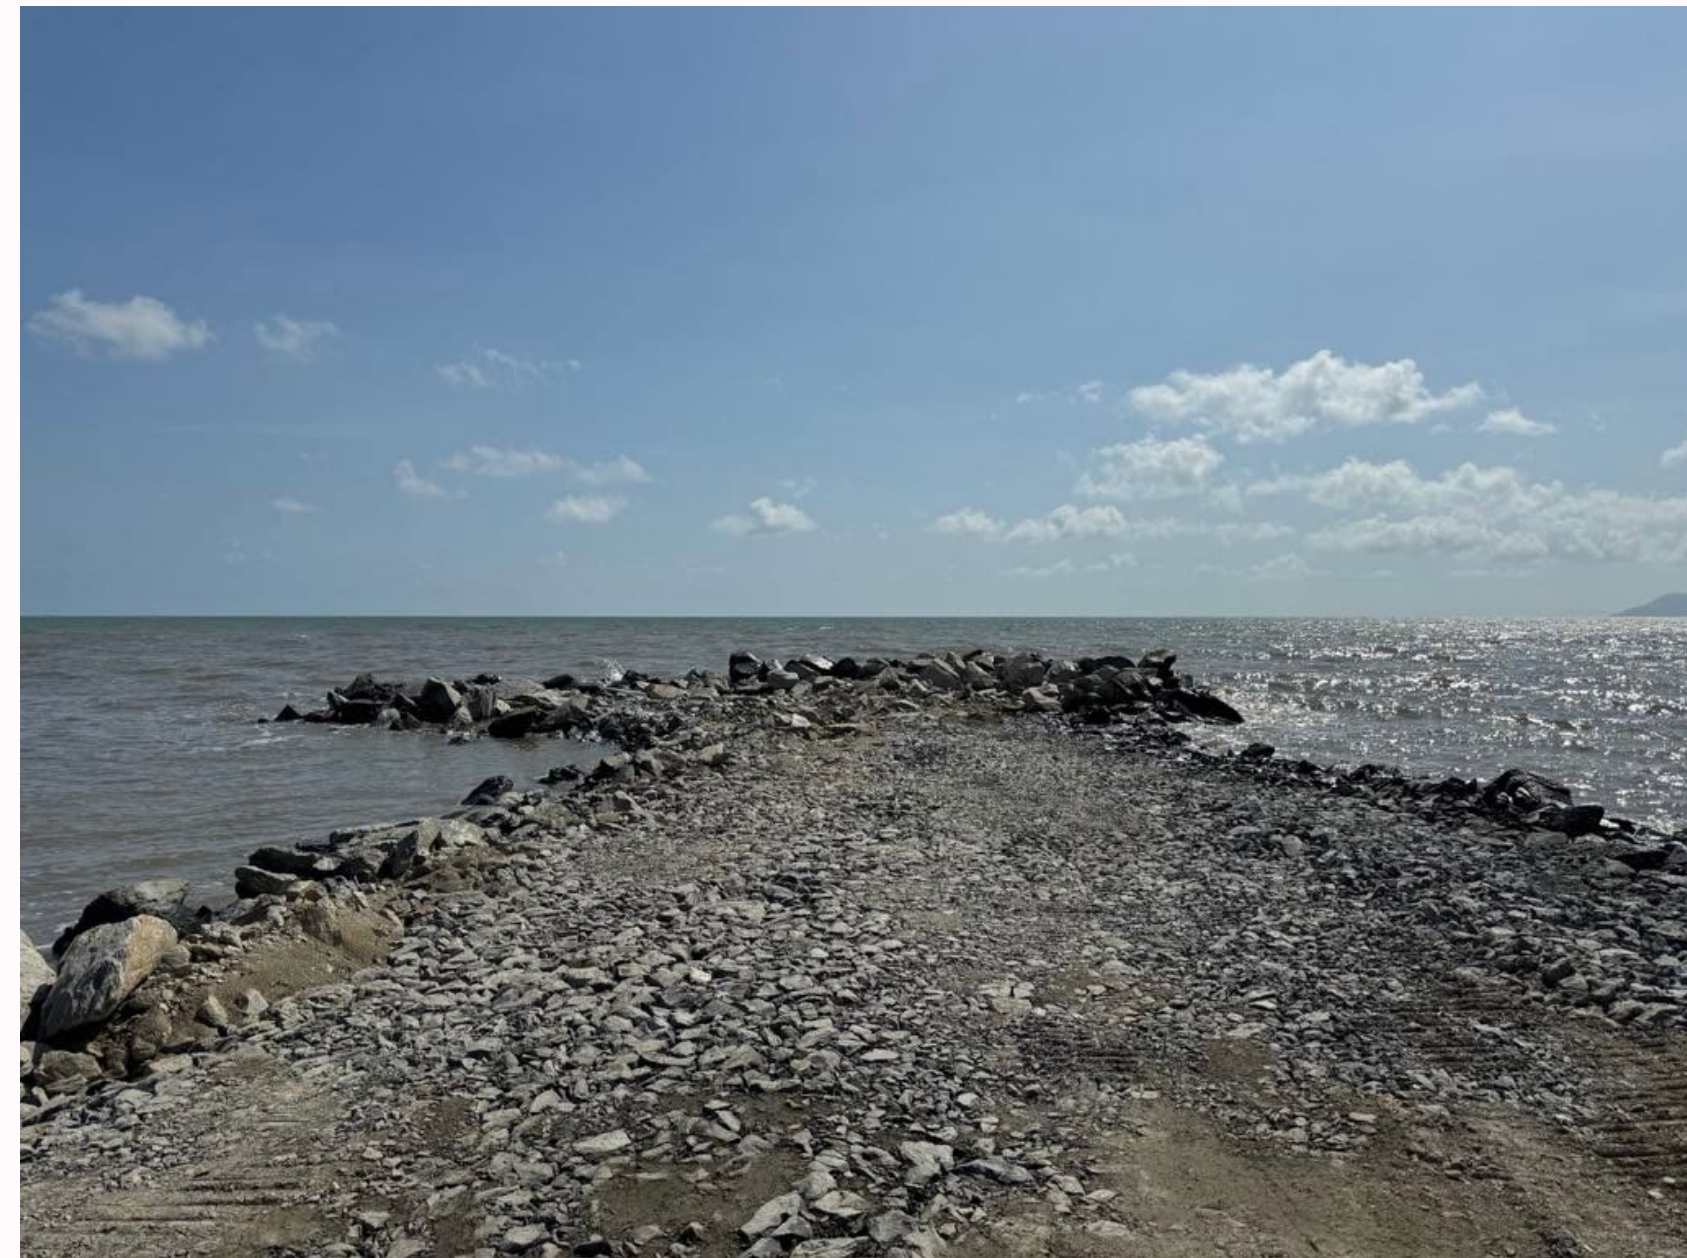
Constructed from beach with a temporary rock track to provide high -tide access to the breakwater.

Limited sand nourishment supply due to TC-Jasper impacts
