# Holloways & Clifton Beach Coastal Resilience Works

Sam King | International Coastal Management

# The Holloways and Clifton Beach Erosion Management Project

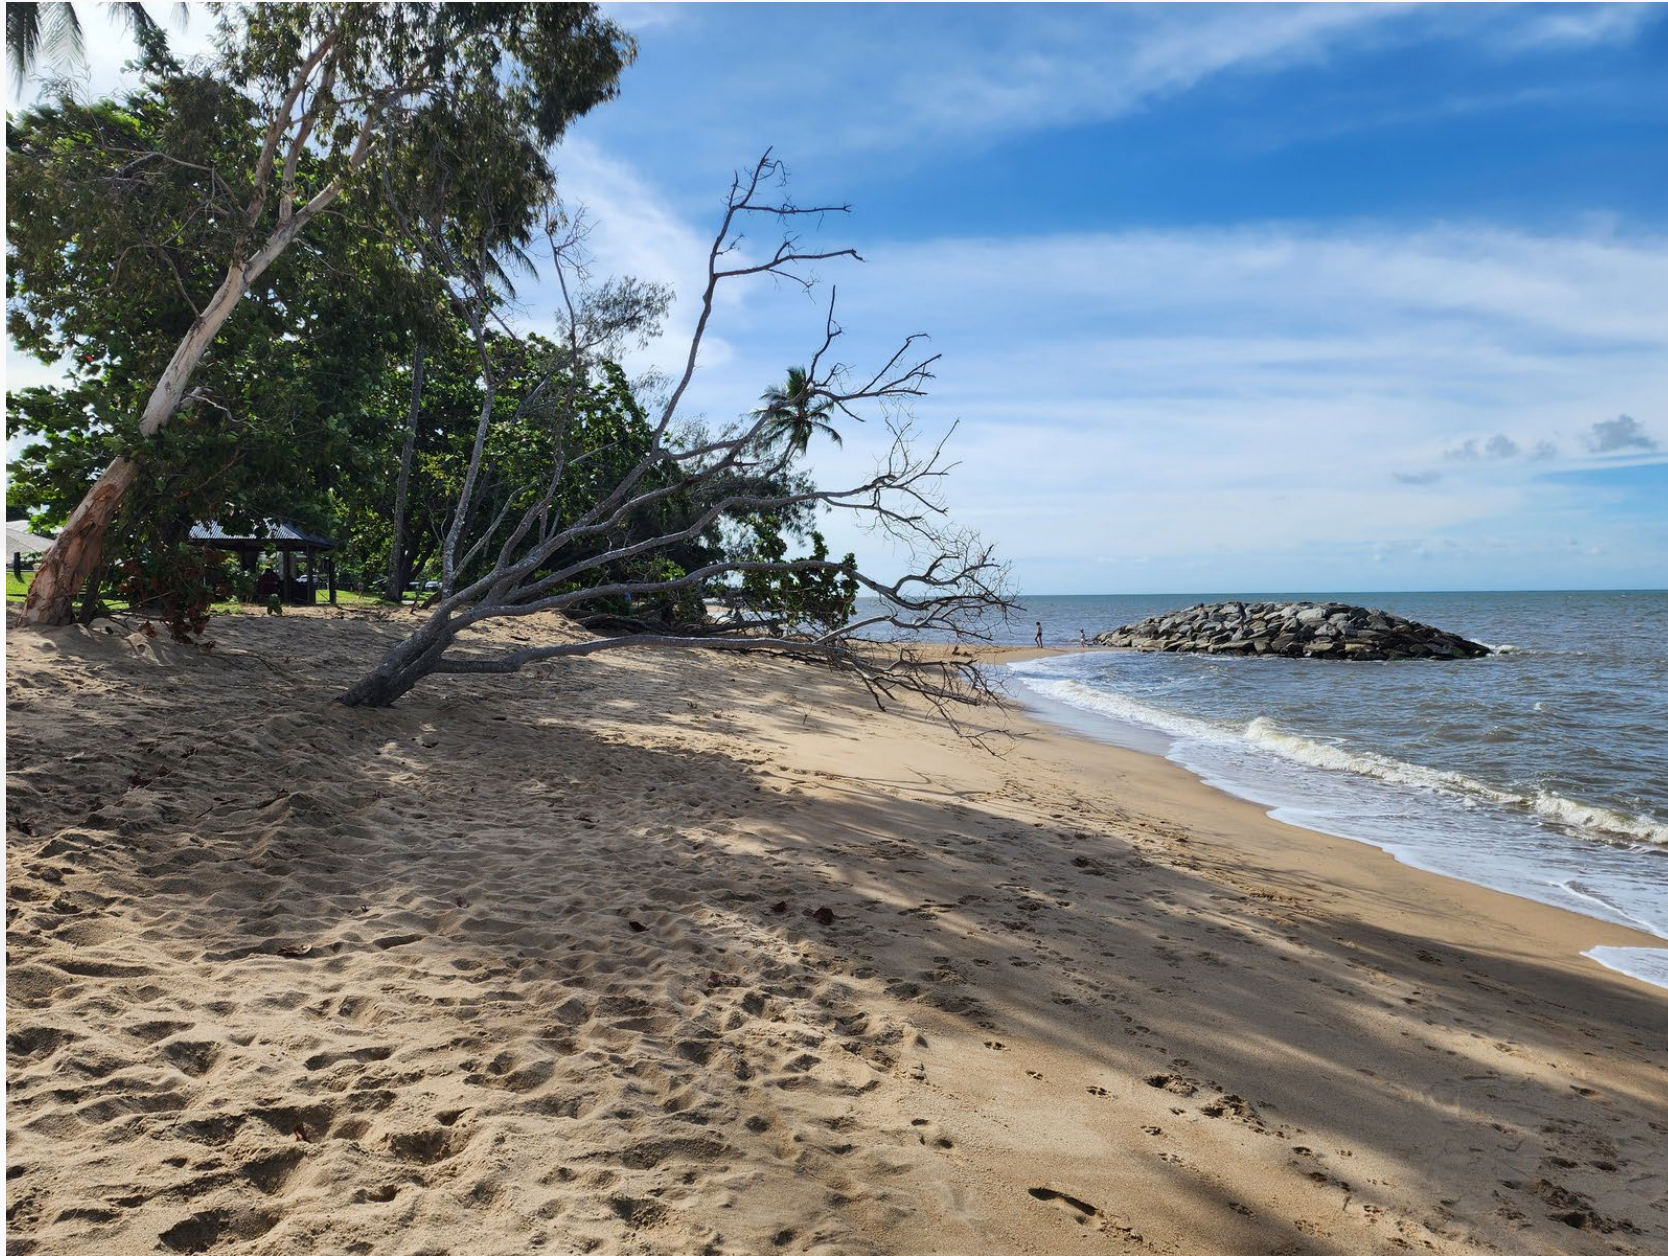
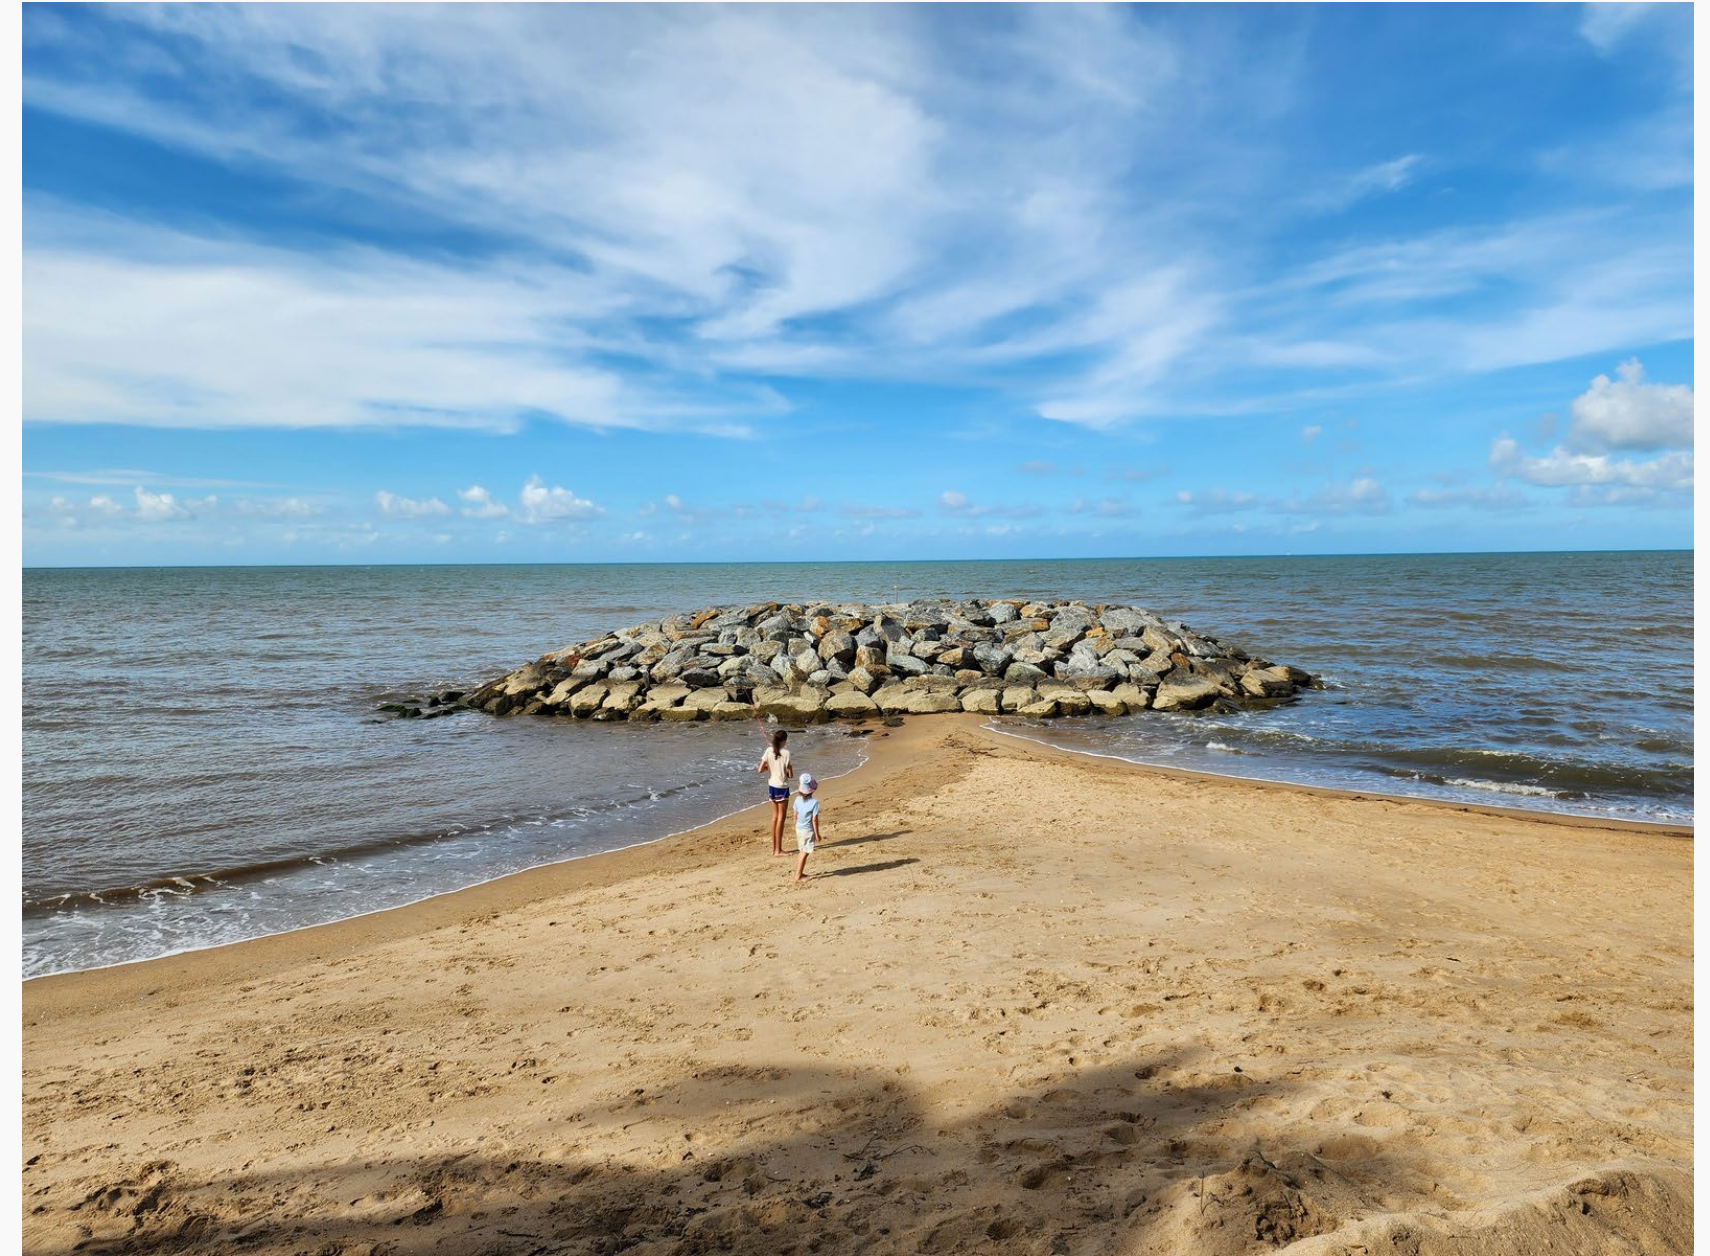
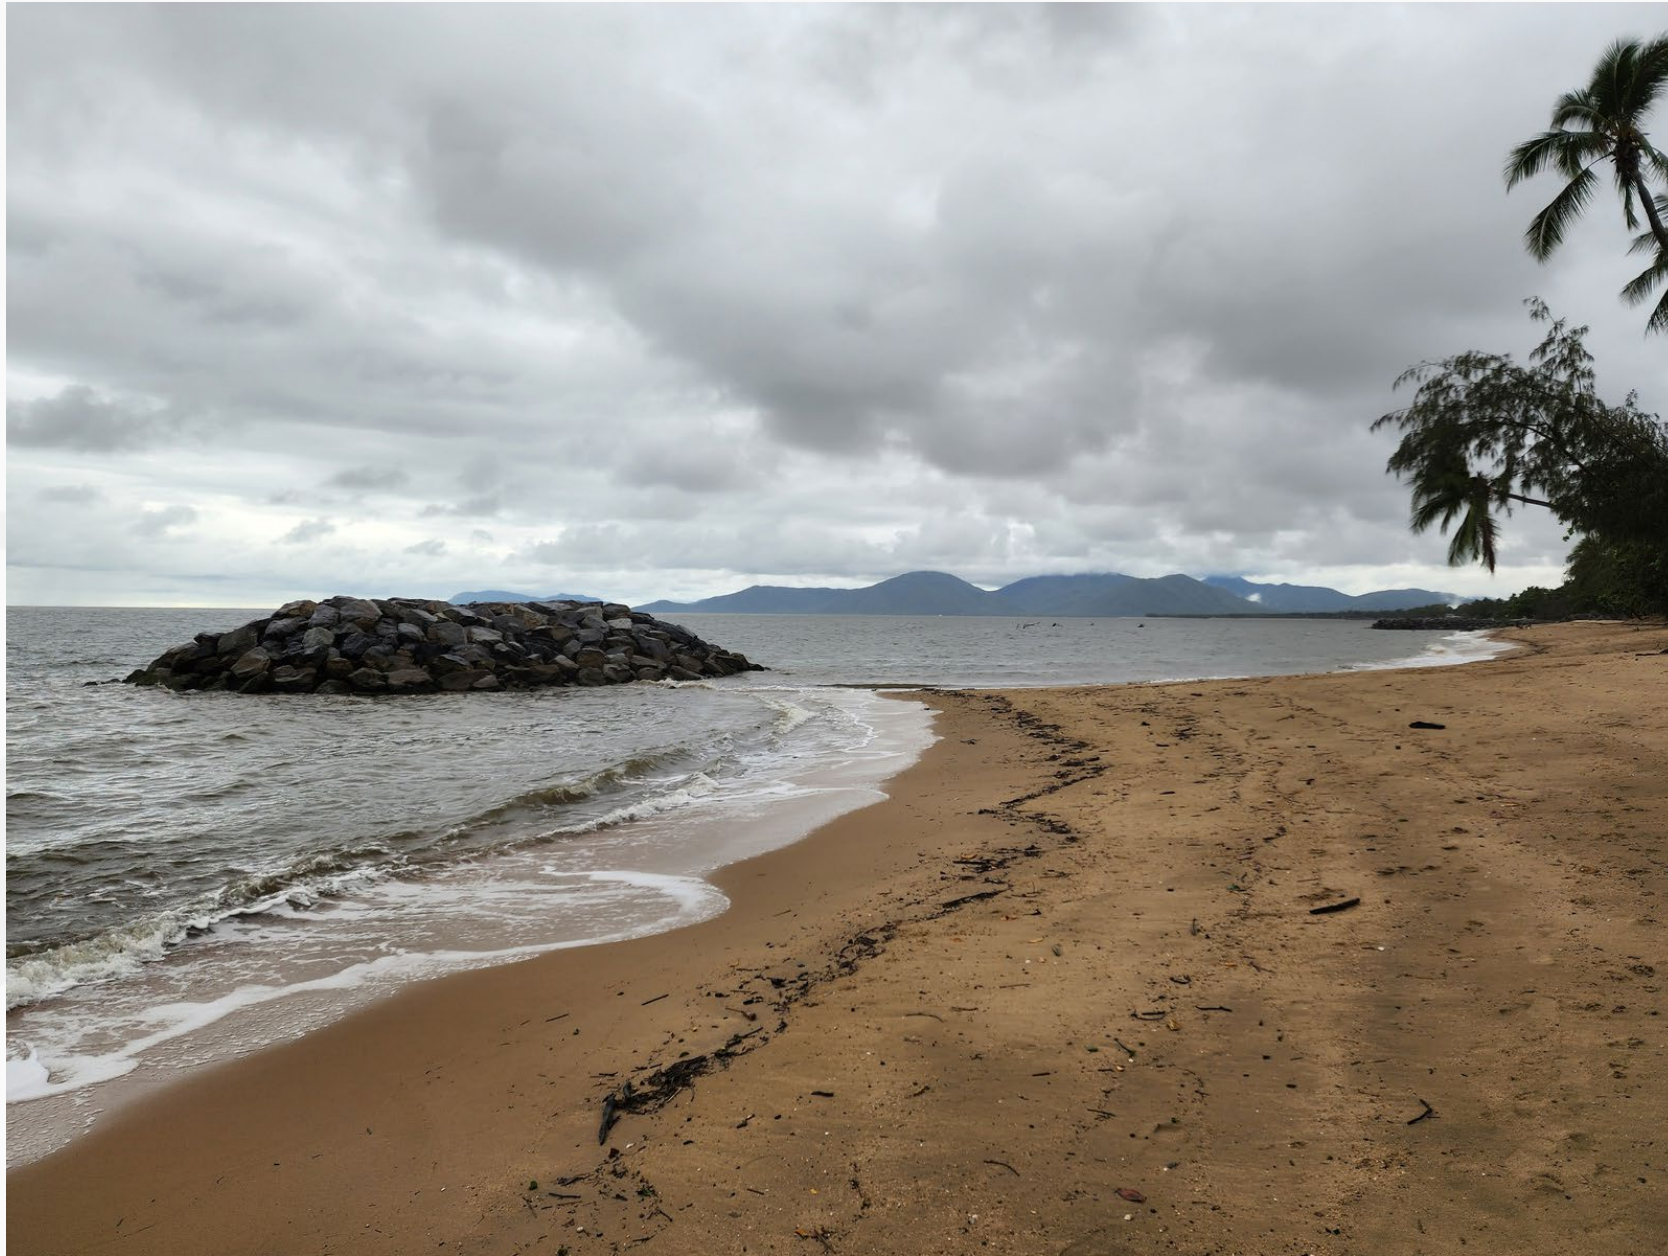
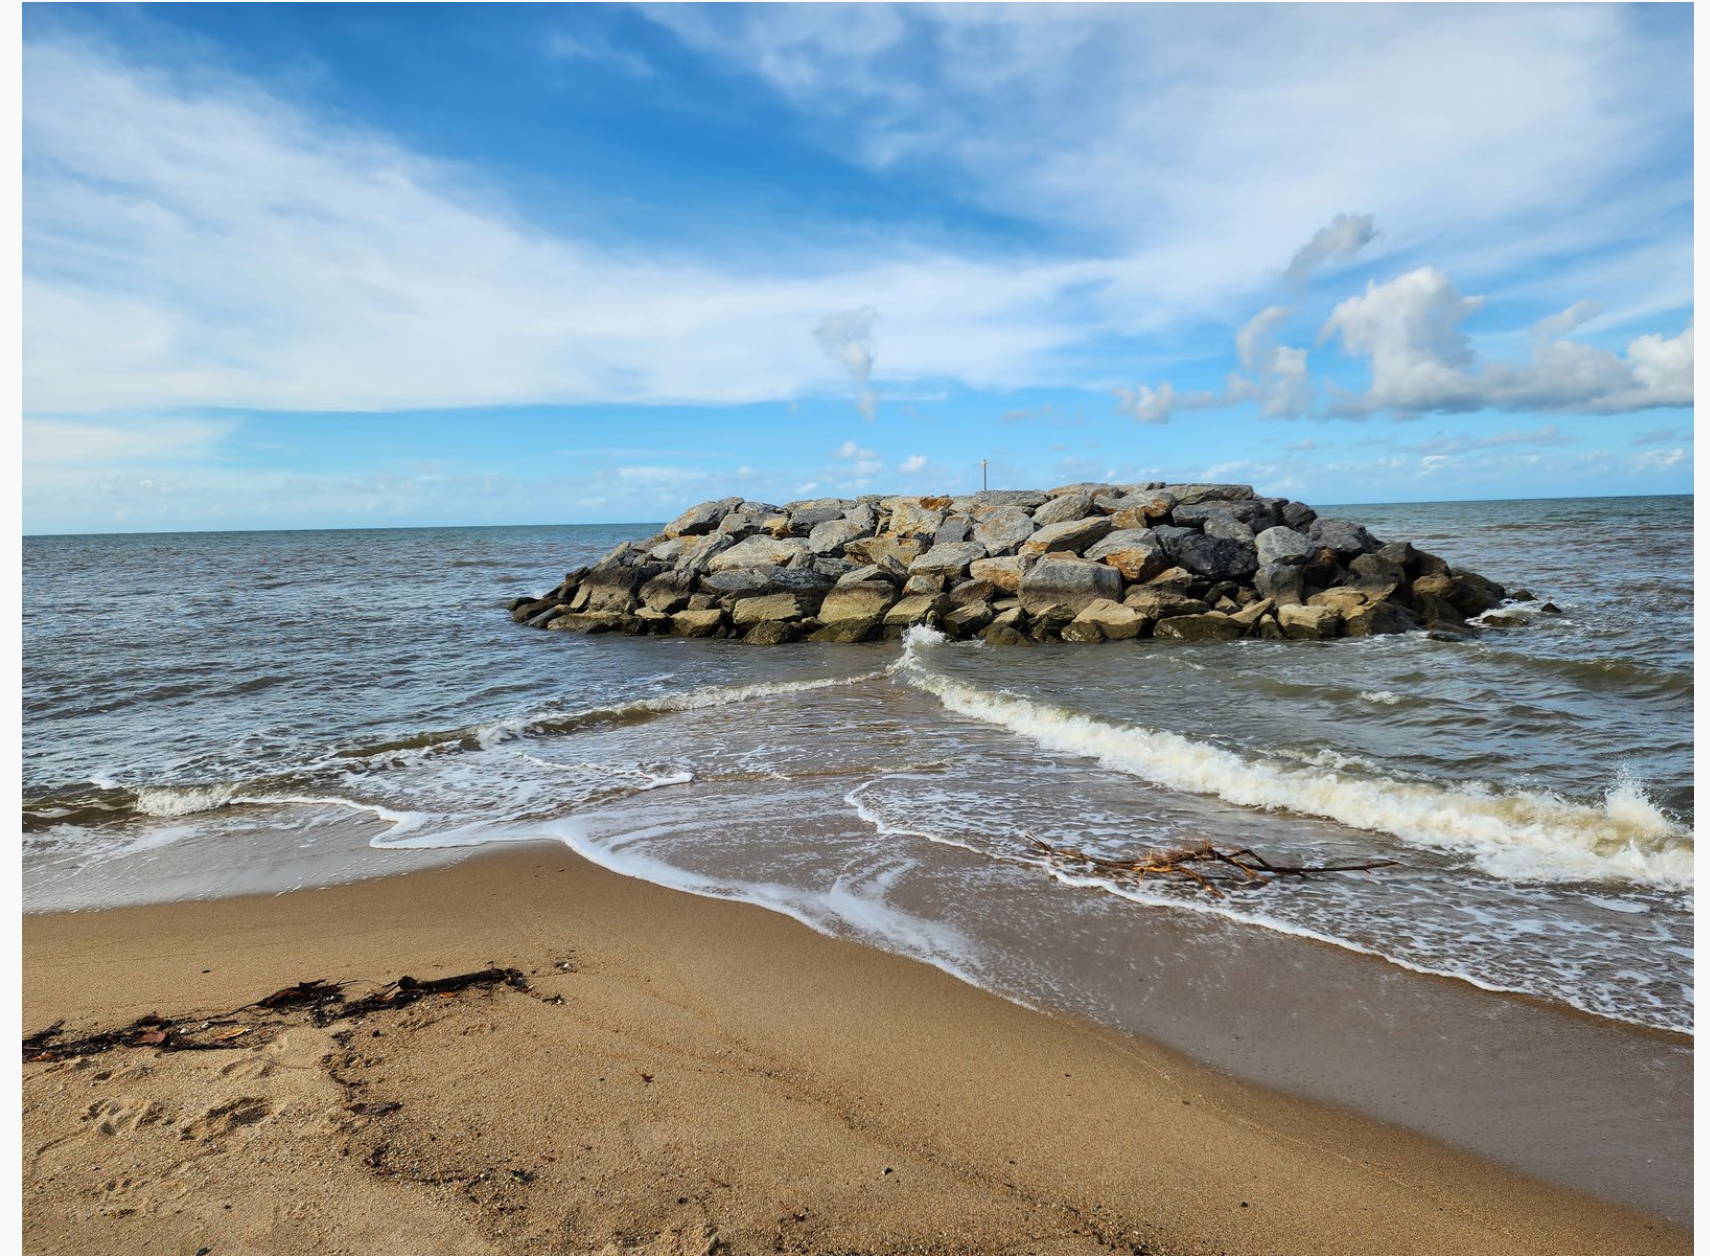
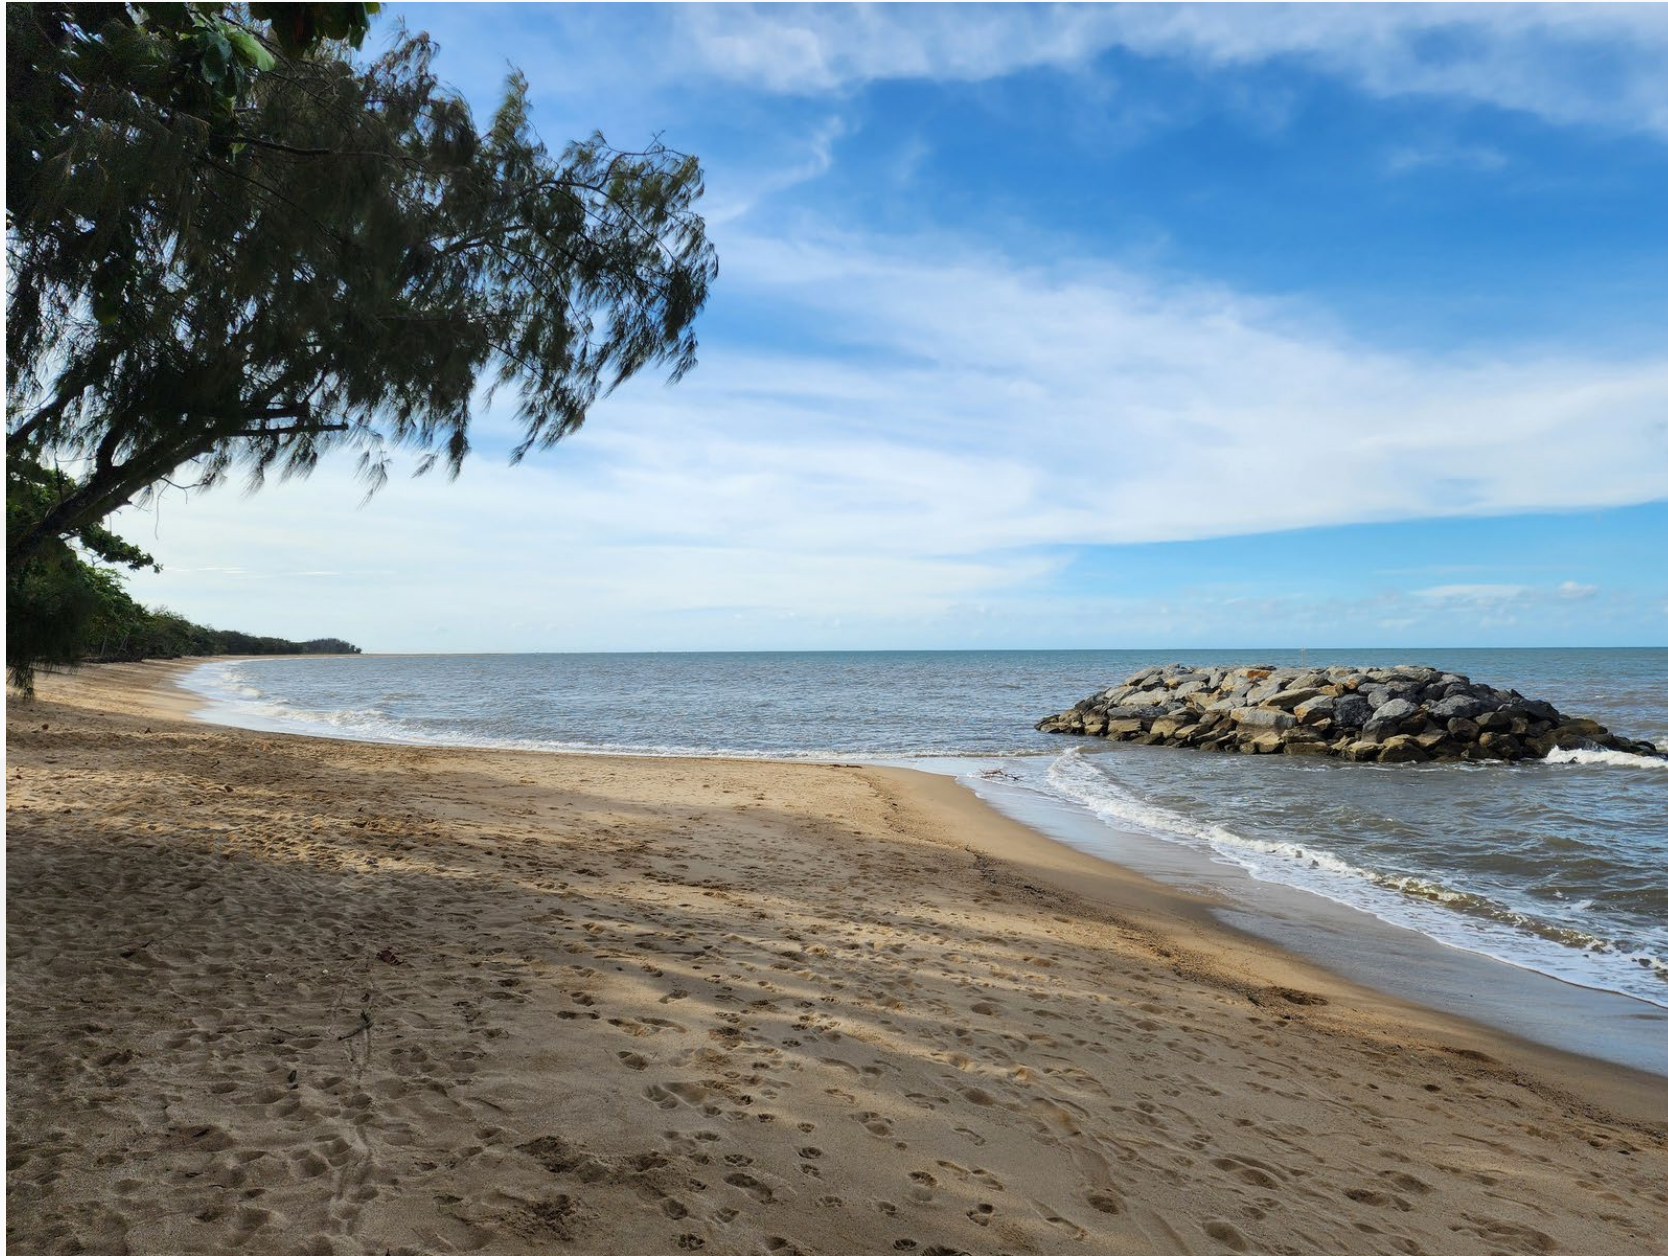
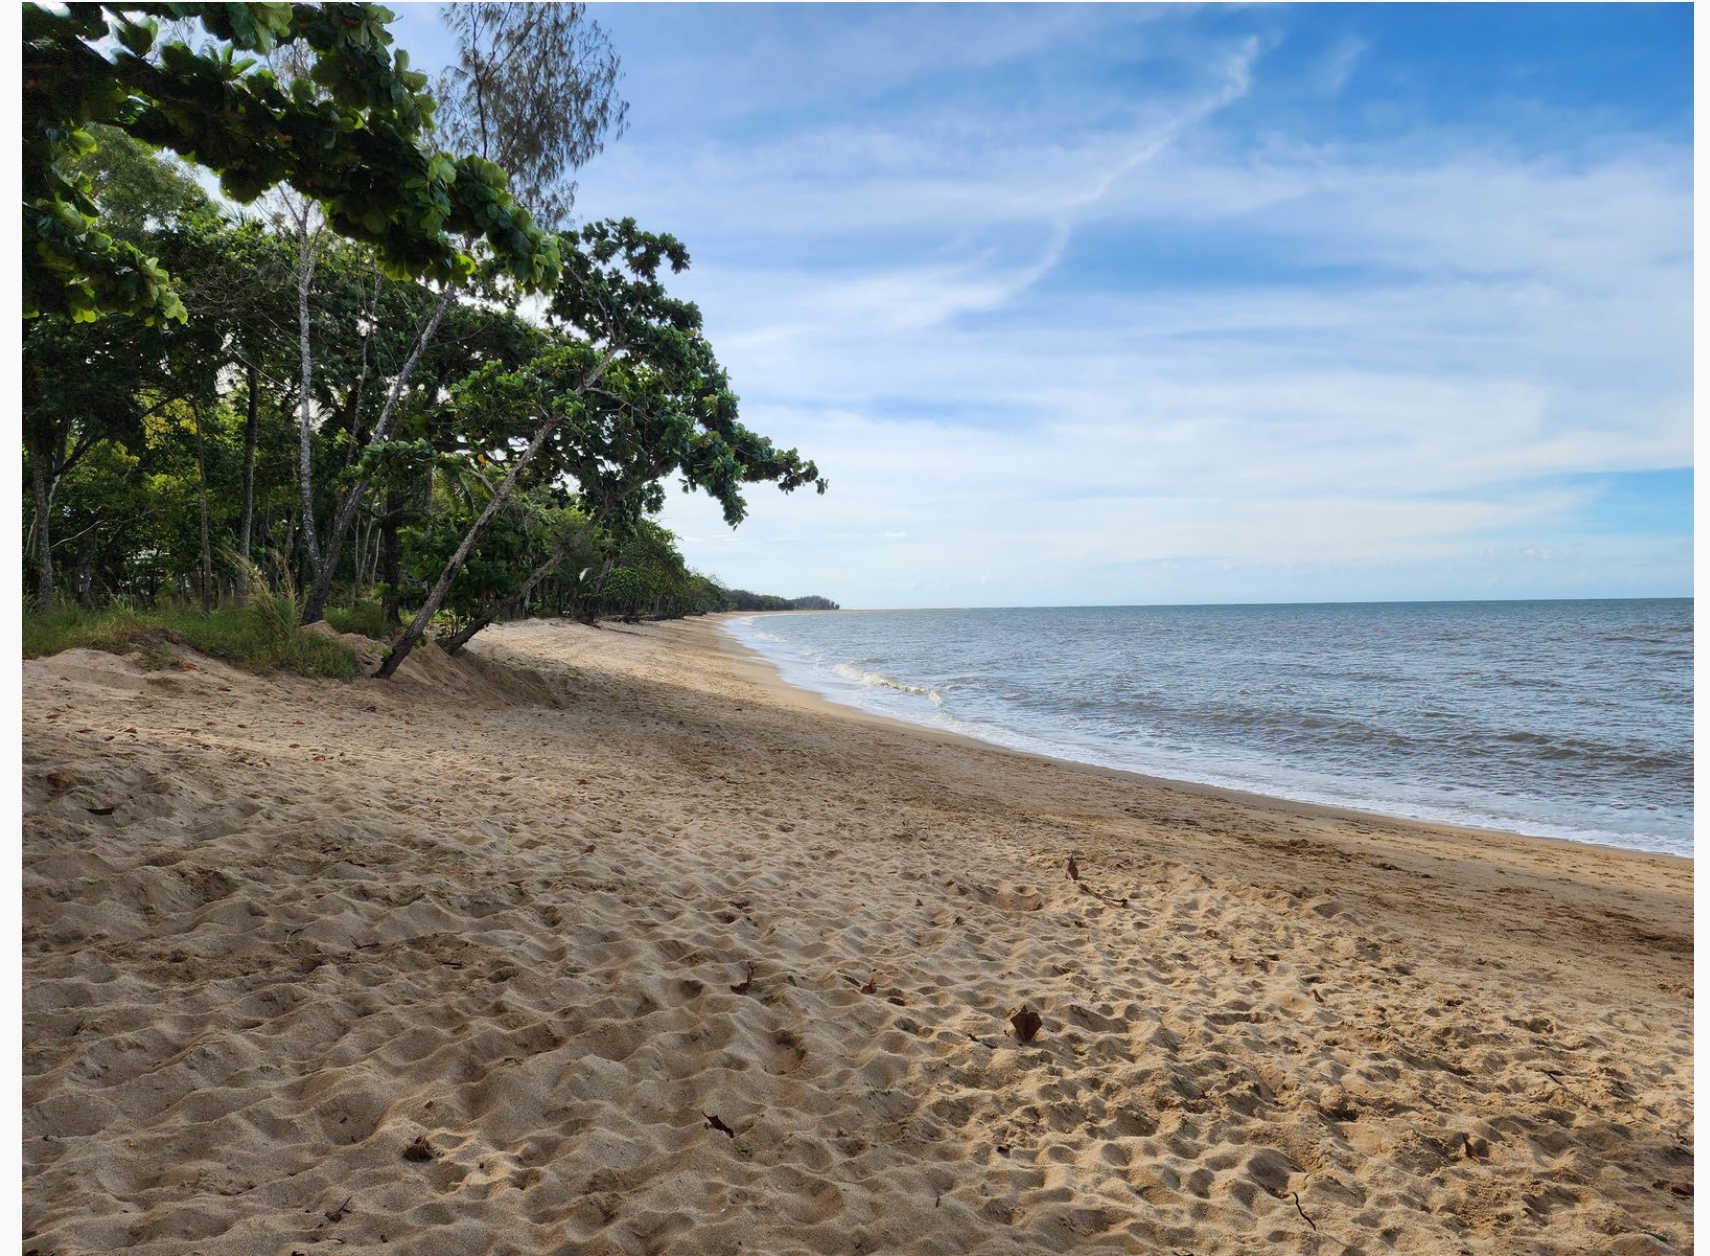
## Preliminary Results (April 2025)

- **Increase in beach width:** 20m to 25m in the lee of breakwaters, 8m to 10m between breakwaters
- **Tombolo formation:** Soft groyne effect at most tides; at higher tides, water bypasses over the tombolo, reducing downdrift erosion
- No erosion scarps present along the high -priority beach
