# Sunshine Coast Council

## Pumicestone Parkland Adaptation

### Pilot project - Case Study

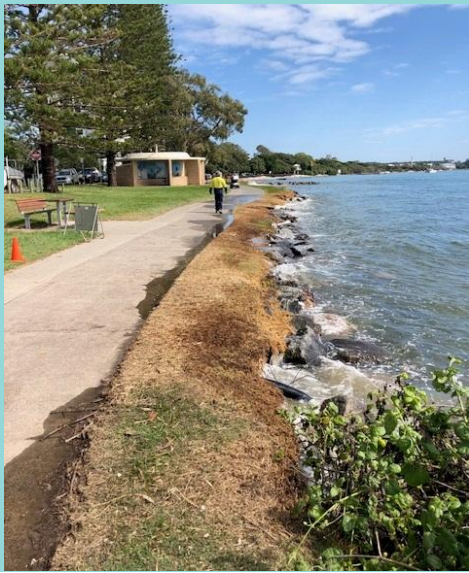
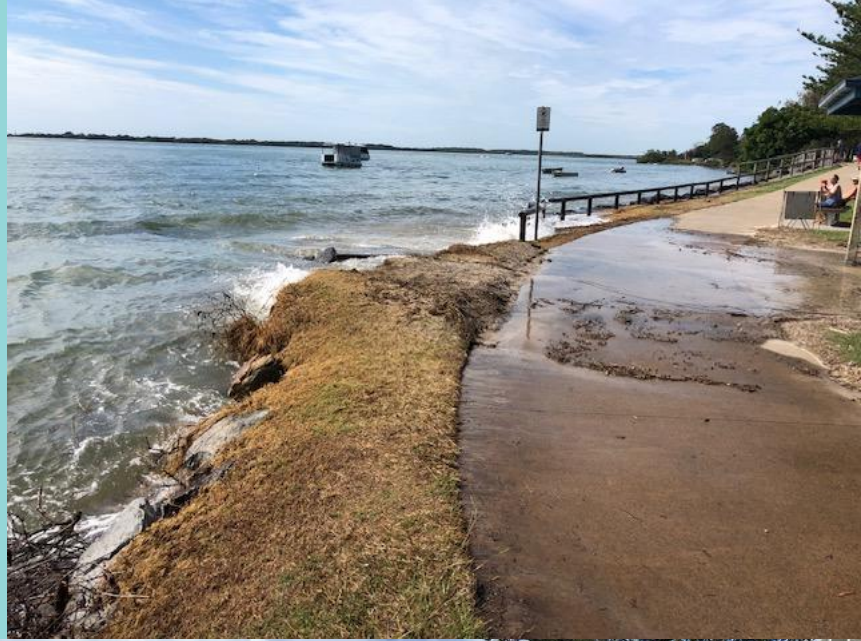
## Before: Early 2022

- *This area of Golden Beach was quite low at around 1.2m HAD. The tidal prism had changed following the BIB and the coastal path and park area was regularly inundated on high tide. Significant erosion along the foreshore was also happening and infrastructure was being negatively affected .*

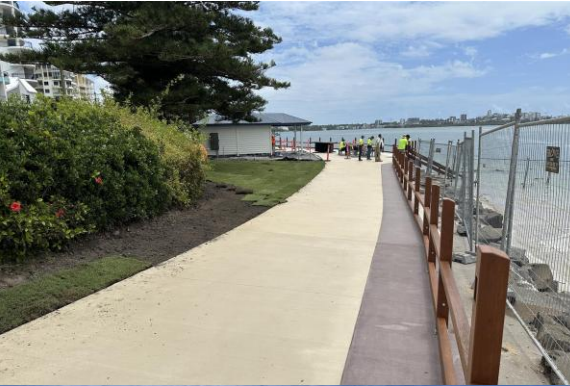
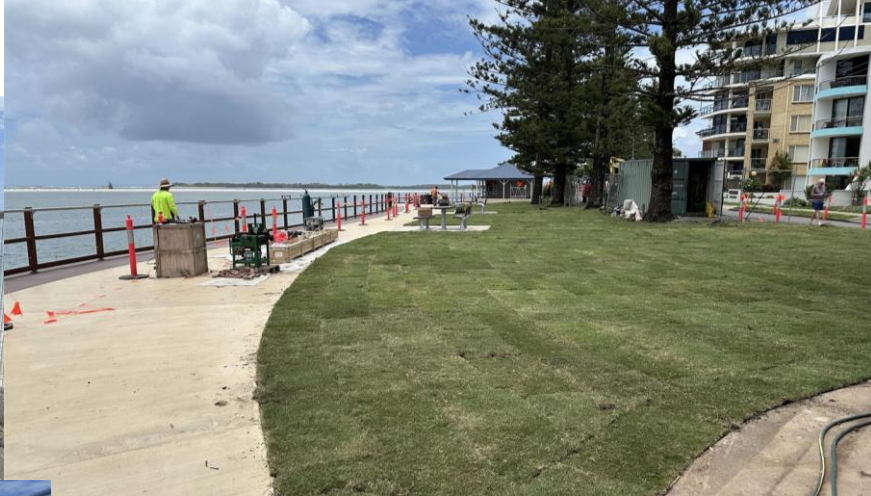
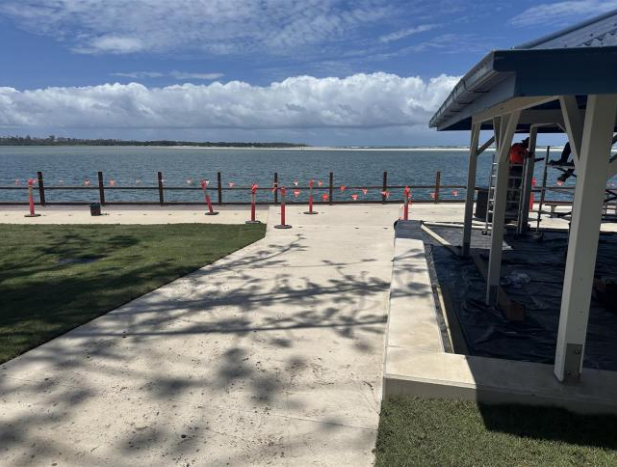
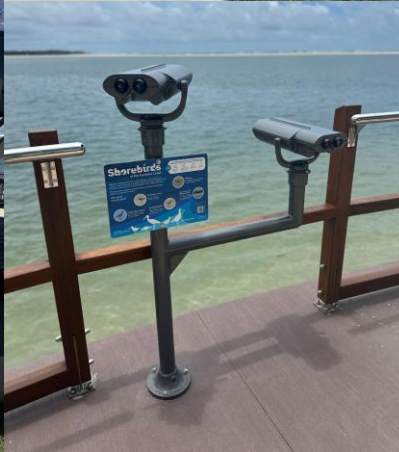
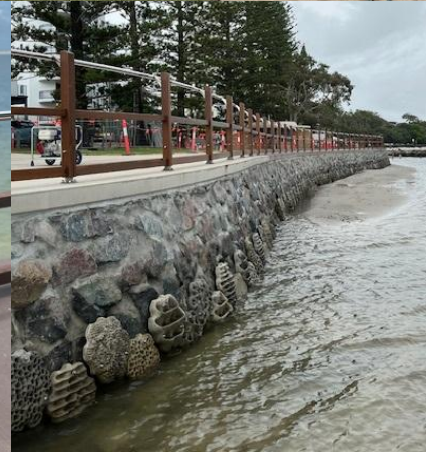
## After: December 2024

- New 80lm seawall constructed in response to Bribie Island Breakthrough
- Parkland raised to 2m AHD (approx. 850-900mm)
- 97 living seawall tiles fitted and monitoring program initiated with USC
- New 4m wide overtopping slab/public walkway which is resilient to climate hazards
- Parkland refurbished (shelter, seats, new balustrades etc)
- New beach access
- New DDA compliant binoculars for viewing shorebirds
